Manhole Inspection Summary

Manhole # S41I__037MH

Location Address: **1300 bank st**

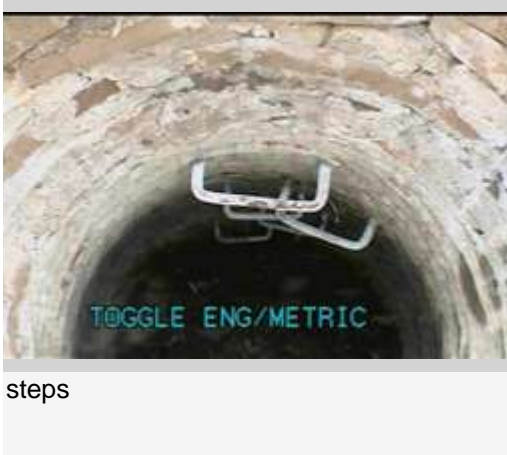
Defect 2

Steps Count: **5** Missing: **0** ☒ **Corroded**

steps

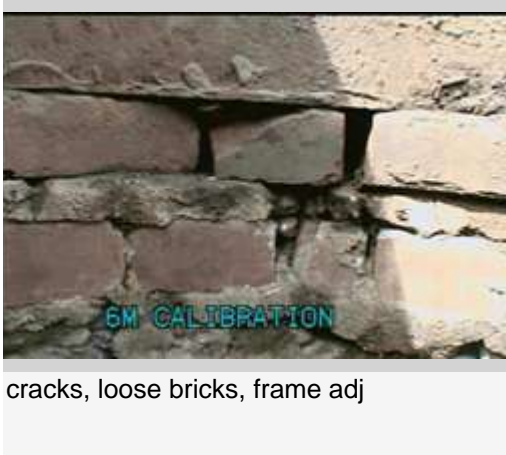
Defect 1

Condition: ☐ Sound ☒ **Cracked** ☐ Root Intrusion ☒ **Loose Brick** ☐ Deteriorated

cracks, loose bricks, frame adj

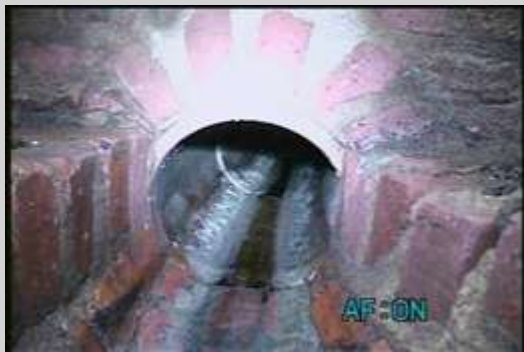
12 O'Clock Outflow

8 in. Circular Gravity Sewer
Pipe Out @ 12 O'Clock

Pipe Material: **Clay** ☐ Pipe Lined

Invert Depth: **9.27** (ft.) Flow Characteristics: **Fast**

Infiltration: **None** Pipe Seal Cond: **Unknown**

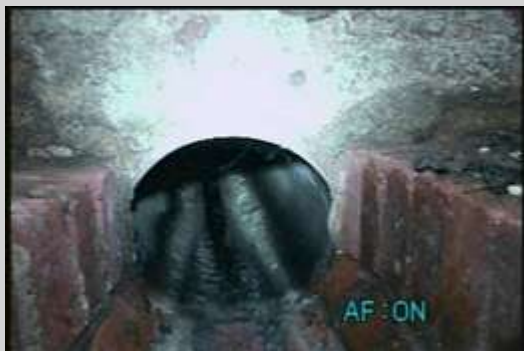
3 O'Clock Inflow

8 in. Circular Gravity Sewer
Pipe In @ 3 O'Clock

Pipe Material: **Clay** ☐ Pipe Lined

Invert Depth: **9.22** (ft.) Flow Characteristics: **Fast**

Infiltration: **None** Pipe Seal Cond: **Unknown**
